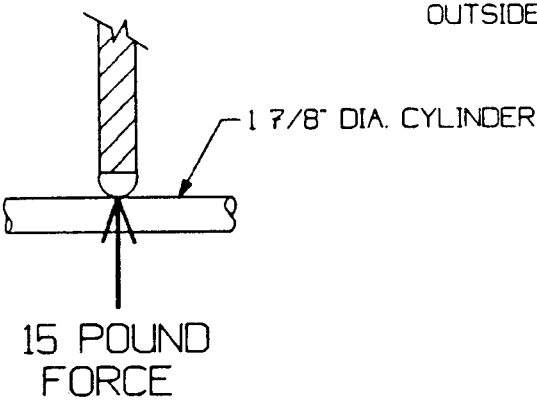
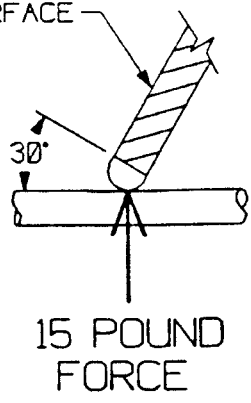
Figure 6

# EDGE SENSOR NORMAL OPERATION TEST

SECTIONAL  
DOOR

ONE PIECE  
DOOR

OUTSIDE SURFACE
